Jeorse Park Beach Ecosystem Restoration Section 506 of WRDA 2000

USACE, Chicago District
January 2019

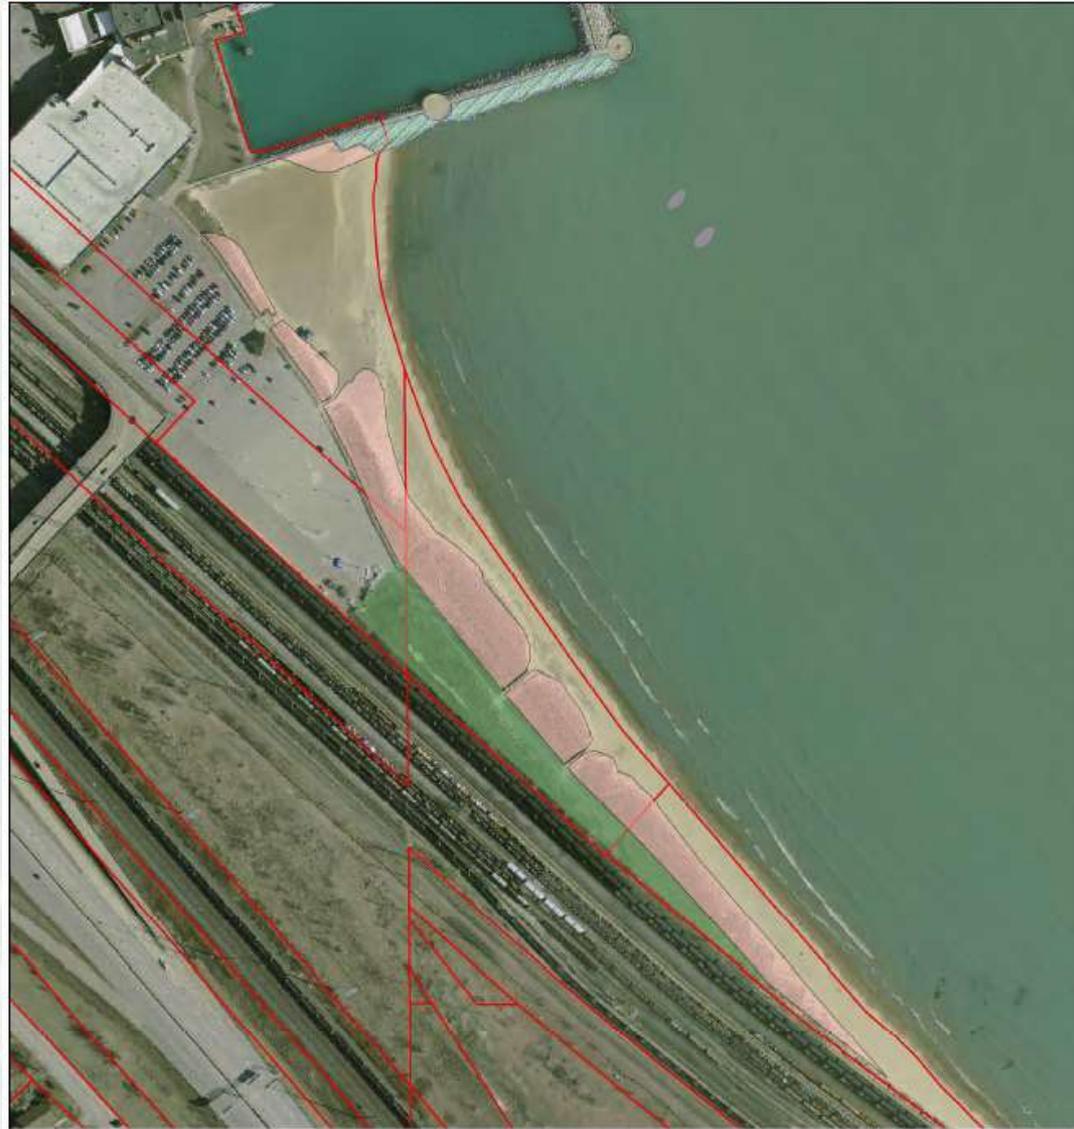
GLFER Restoration Project Features

Breakwater Plantings - 5,100 Shrubs & 2,000 Plugs
-

Beach Plants - 1,500 Shrubs & 33,000 Plugs
-

Pine Plantings - 80 White Pine, 25 Jack Pine, 500 Shrubs & 6,000 Plugs
-

Rock Reef - 2 cobble mounds provide 25 acres of fisheries benefits

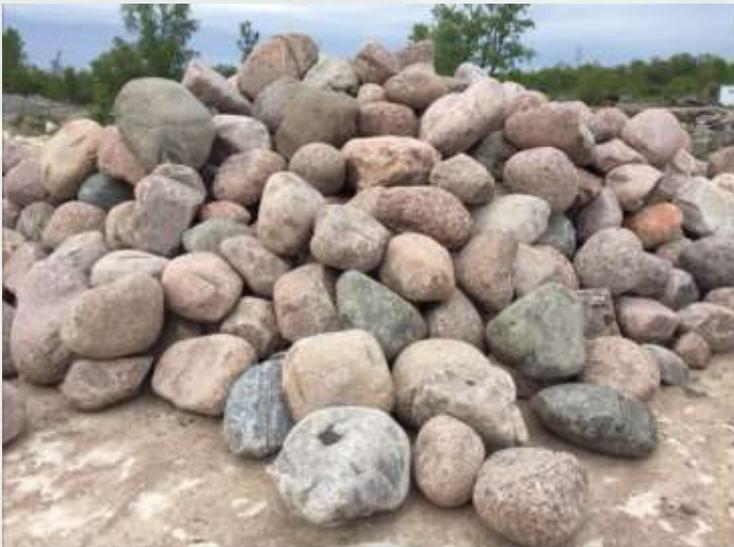
Representative
cobble material
used in construction
of rock reef habitat

- Initial invasive species removal
- Breakwater aggregate and sand planting medium placement:
 - ▶ Cover crop was seeded for winter 2017-18 protection
 - ▶ Safety issue (sink holes) identified – contract mod for railing
- Cobble mound fish reefs were installed 20 July 2017

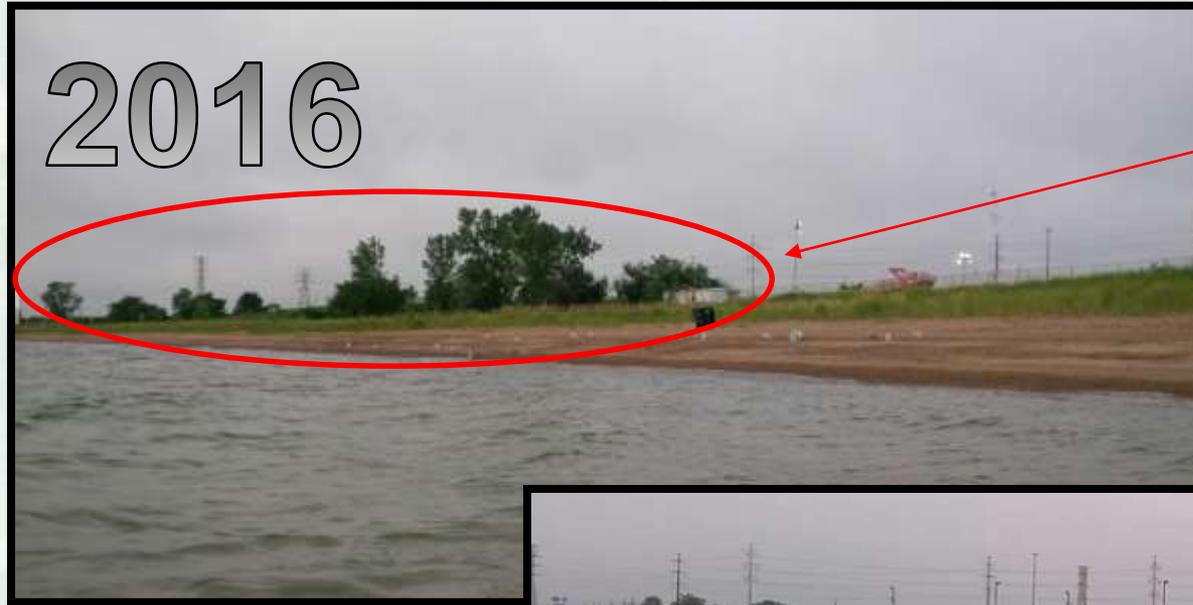
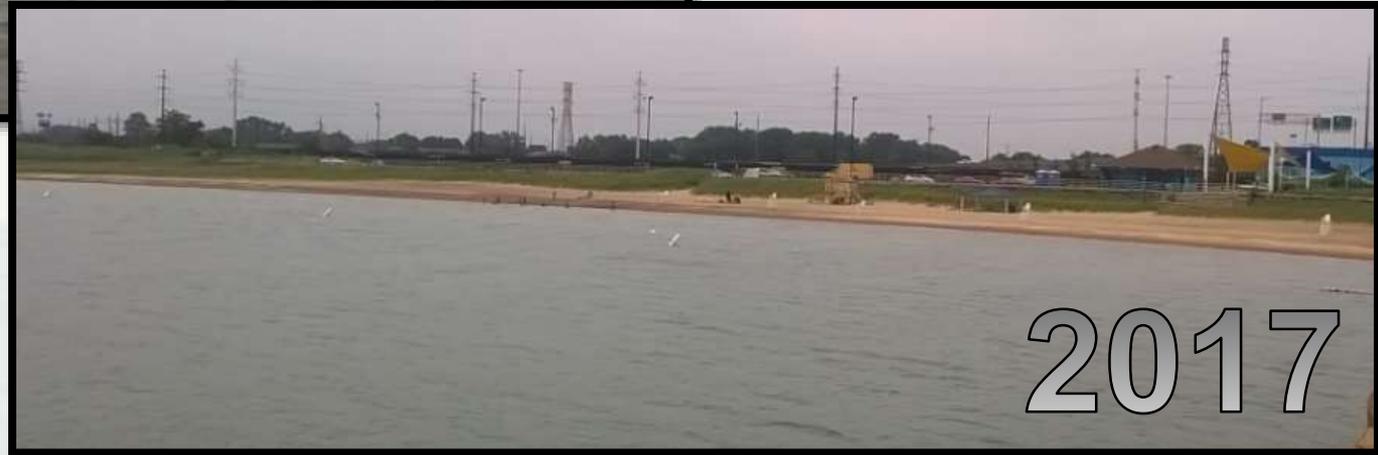
Woody Invasive Species Removal

Removed aggressive native and invasive tree species such as Russian Olive and Cottonwood.

Replaced with White and Jack Pines more suitable for dune habitat.

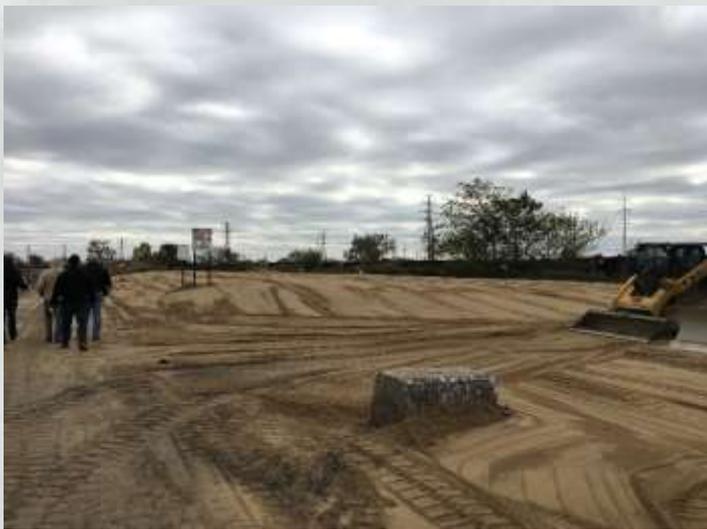
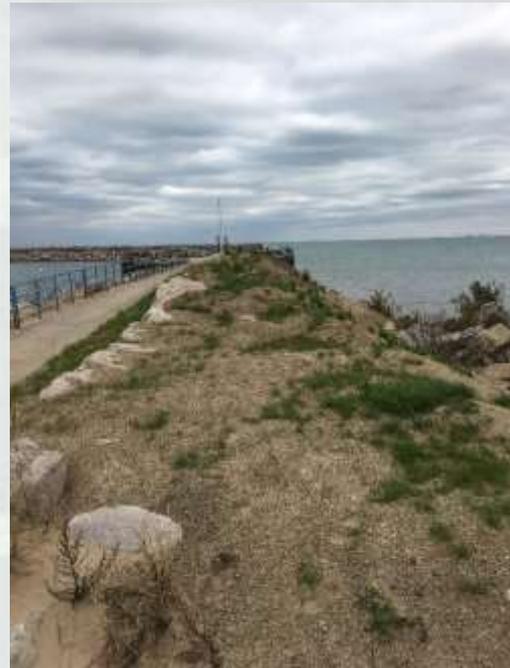
- ❑ Land-moving and grading activities completed on the dune habitat
- ❑ Seeding native species occurred across pine planting, dune, and beach habitats following sand placement and earth moving

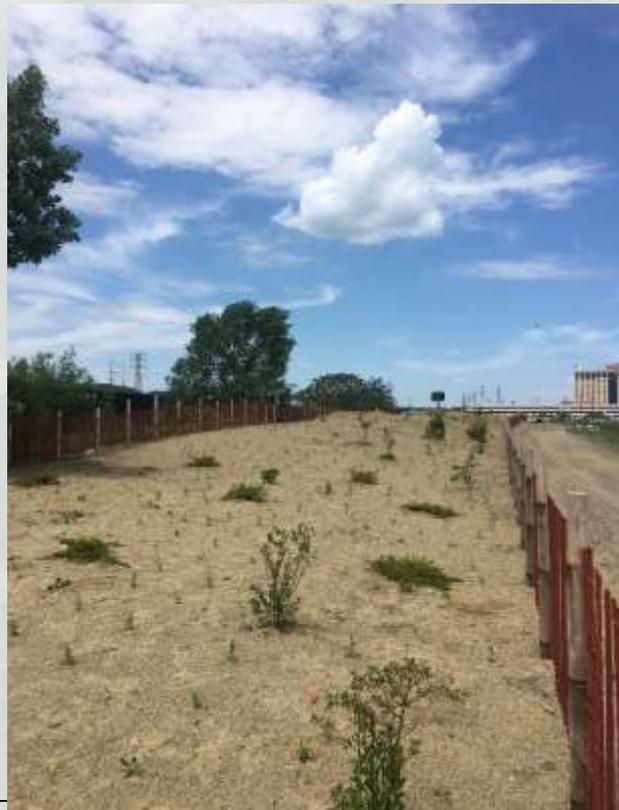
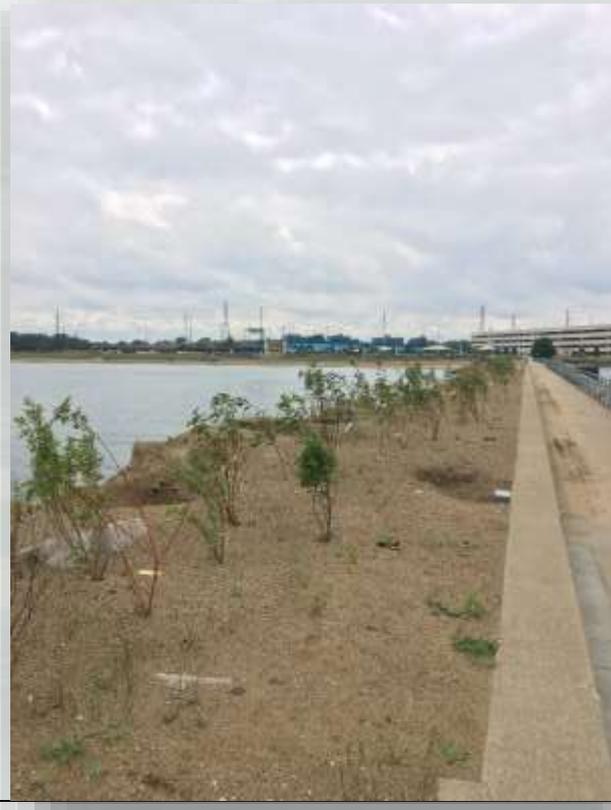
- ❑ **Plugs, Shrubs and Trees planted Spring 2018**
 - Propagation issues with several species pushed the planting schedule into the second year of contract
 - Contractor remains responsible for initial performance criteria at end of year 5

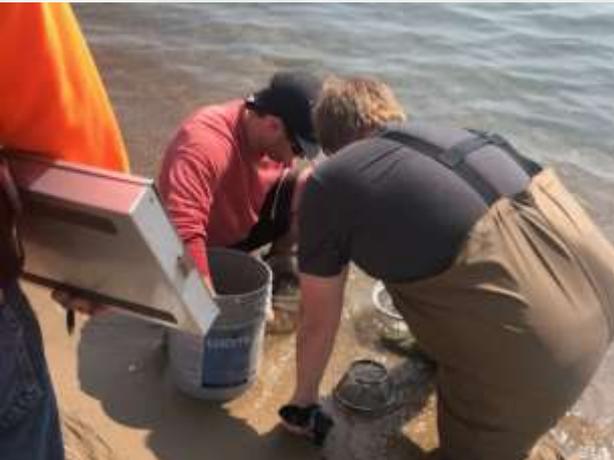
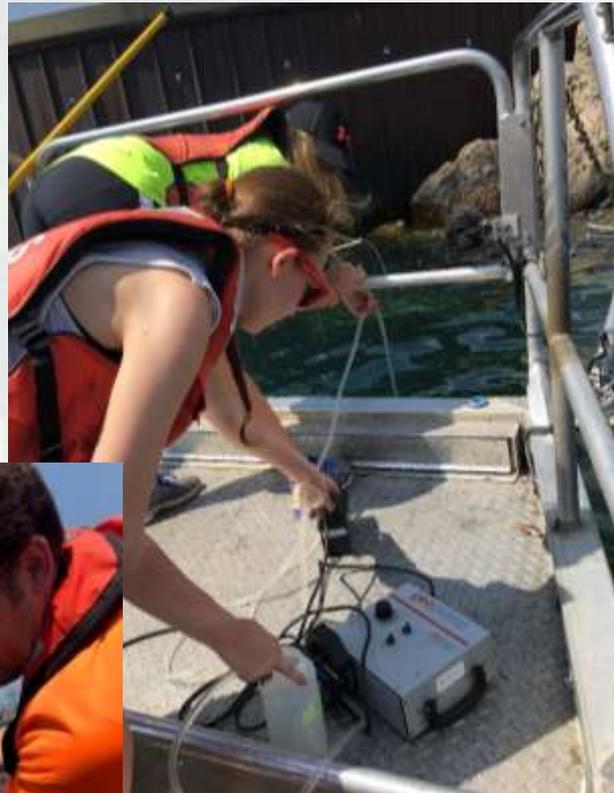
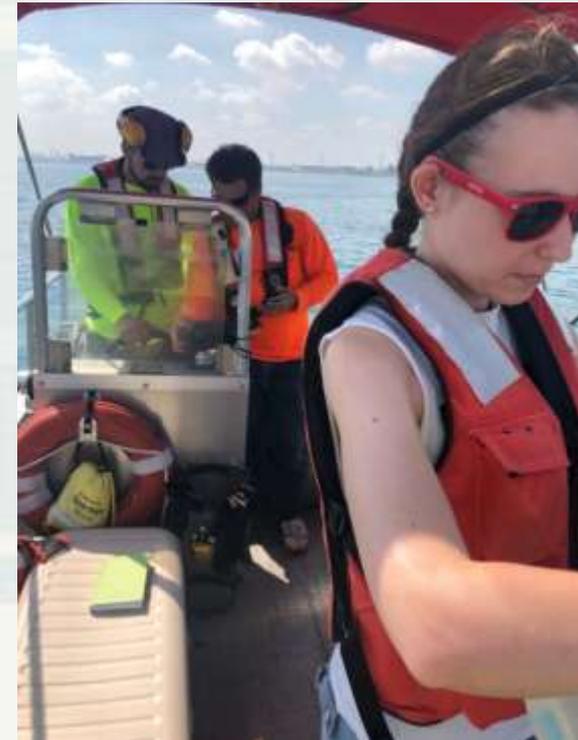
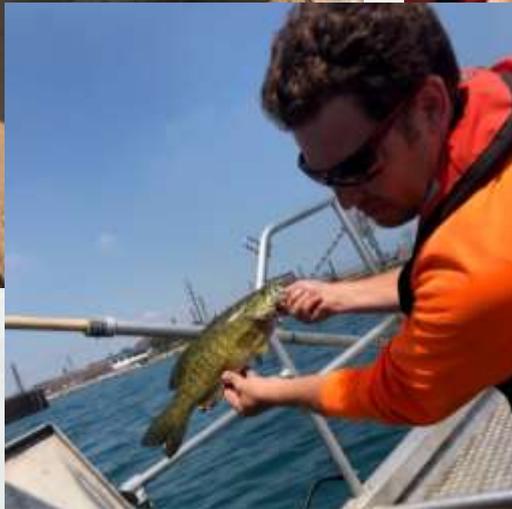
28 June 2018 – Two 15 minute Electrofishing runs & One seine haul

- Collected 362 individuals from 9 species
- Yellow Bullhead, Smallmouth Bass, Round Goby*, Pumpkinseed Sunfish, Rock Bass, Shorthead Redhorse, Spottail Shiner, Sand Shiner, and Banded Killifish
